**DEPARTMENT OF TRANSPORTATION**

Contract #: 04-0120F4Cty: SF/ALA Rte: 80 PM: 13.2/13.9File #: 1.28**WELDING INSPECTION REPORT****Resident Engineer:** Casey, William**Address:** 333 Burma Road**City:** Oakland, CA 94607**Report No:** WIR-027709**Date Inspected:** 06-Jun-2012**Project Name:** SAS Superstructure**OSM Arrival Time:** 700**Prime Contractor:** American Bridge/Fluor Enterprises, a JV**OSM Departure Time:** 1730**Contractor:** American Bridge/Fluor Enterprises, a JV**Location:** Job Site**CWI Name:** Fred Michels**CWI Present:** Yes No**Inspected CWI report:** Yes No N/A**Rod Oven in Use:** Yes No N/A**Electrode to specification:** Yes No N/A**Weld Procedures Followed:** Yes No N/A**Qualified Welders:** Yes No N/A**Verified Joint Fit-up:** Yes No N/A**Approved Drawings:** Yes No N/A**Approved WPS:** Yes No N/A**Delayed / Cancelled:** Yes No N/A**Bridge No:** 34-0006**Component:** SAS Tower**Summary of Items Observed:**

# WELDING INSPECTION REPORT

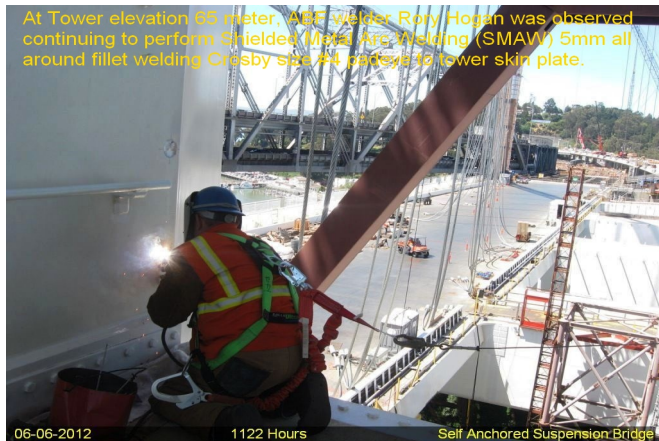
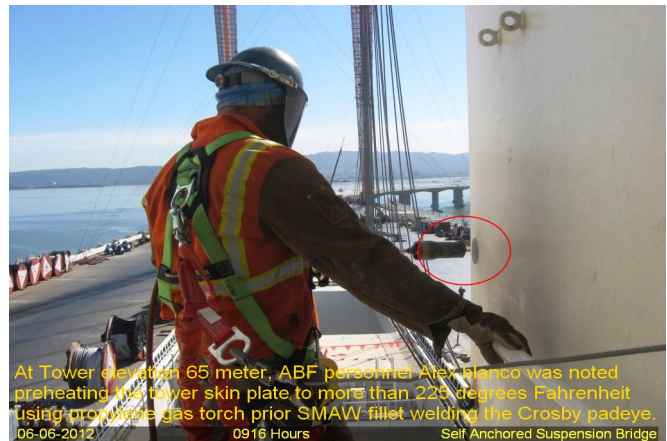
At Tower elevation 65 meter, QA randomly observed ABF/JV qualified Rory Hogan continuing to perform all position Shielded Metal Arc Welding (SMAW) fillet welding Crosby size number 4 padeye on tower skin plates. There were four padeyes being welded on tower skin plates A and E on tower shafts South and East while there are only two being welded padeyes on tower skin plate A of tower shafts North and West. The padeyes are also being welded per Contract Change Order (CCO) #201 and per Caltrans approved drawing Tower Access Detail #30.

Prior welding, ABF foreman Rory Hogan was noted laying out the location of the padeyes while another ABF personnel was noted grinding off the paint on the tower where the padeye will be welded. After grinding, the same personnel preheated the tower skin plate to required temperature of more than 225°F. After reaching the required preheat temperature, ABF welder Rory Hogan performed the tack welding using SMAW with 3.2mm diameter E7018H4R electrode with measured working current of 130 amperes on the mentioned electrode.

As soon as the padeye is tack welded, the welder immediately preheated the tower skin plate and the padeye itself to the required preheat temperature of more than 225°F. The welder then fully fillet welded the Crosby Padeye to 5mm all around fillet using the same electrode and size. During fillet welding, ABF QC Fred Michels was observed monitoring the preheat temperature and working current.

At the end of the shift, the welder has completed fillet welding a total of 12 padeyes at tower four shafts elevation 65 meters.
